**INSPECTION OF STRYKER TRANSMISSIONS
EVALUATED USING SCPL IN A 20K MILE RAM-D
TEST**

**INTERIM REPORT
TFLRF No. 457**

July 2014

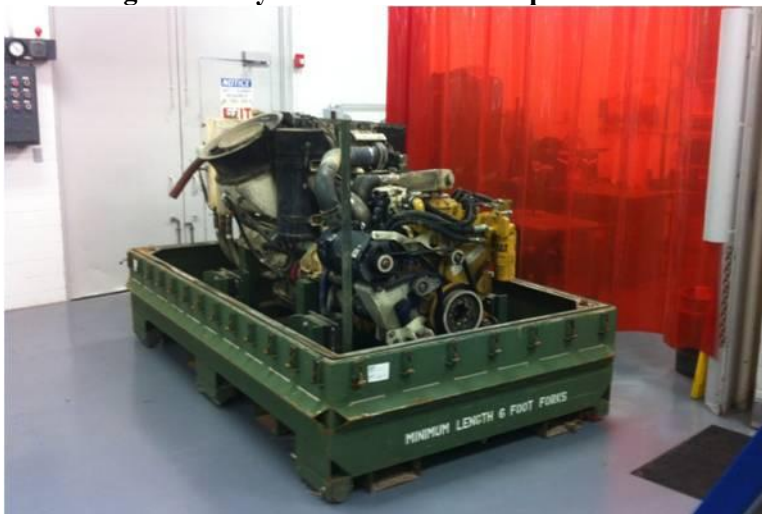
Each transmission was sent to TFLRF in a fully assembled powerpack, in the same manner they would typically be removed from the vehicle for service. This was done as the Caterpillar 3126 engine was needed to support an earlier work directive that covered the engine inspection. Once received, the shipping containers were opened and moved indoors to facilitate disassembly of the full power pack. Figure 1 and Figure 2 show the powerpack assembly of Stryker MEV-013 (CONTROL) prior to removal. The photos below are representative of the condition that both power packs were received in for inspection.

Figure 1. Stryker MEV-013 Powerpack 1

Figure 2. Stryker MEV-013 Powerpack 2

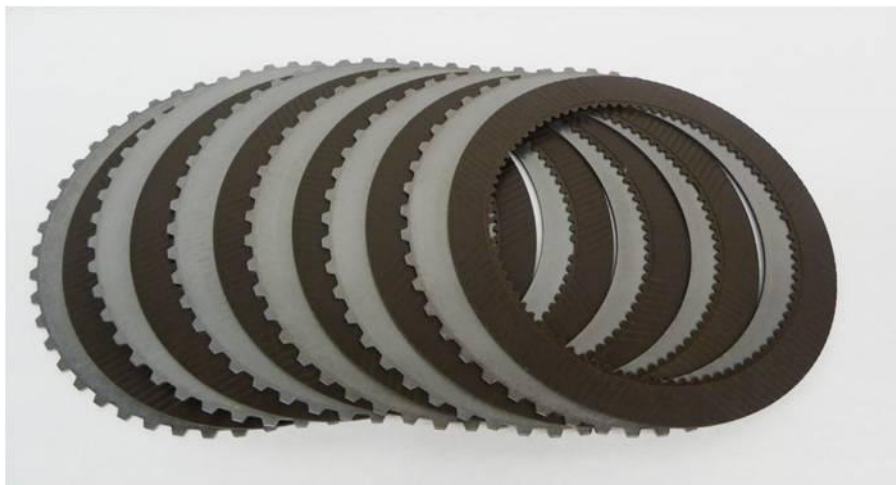
The C1 and C2 clutch assemblies for the TEST and CONTROL transmissions showed nearly identical condition upon removal. No discoloration or glazing was noted on the friction disks, and the reaction plates showed no unusual wear or signs of heat from excessive slipping. Figure 3 through Figure 6 show an overview photo of each C1 and C2 clutch assembly for the TEST and CONTROL units.

Figure 3. CONTROL Transmission C1 Clutch Assembly

Figure 4. TEST Transmission C1 Clutch Assembly

Figure 5. CONTROL Transmission C2 Clutch Assembly

Figure 6. TEST Transmission C2 Clutch Assembly

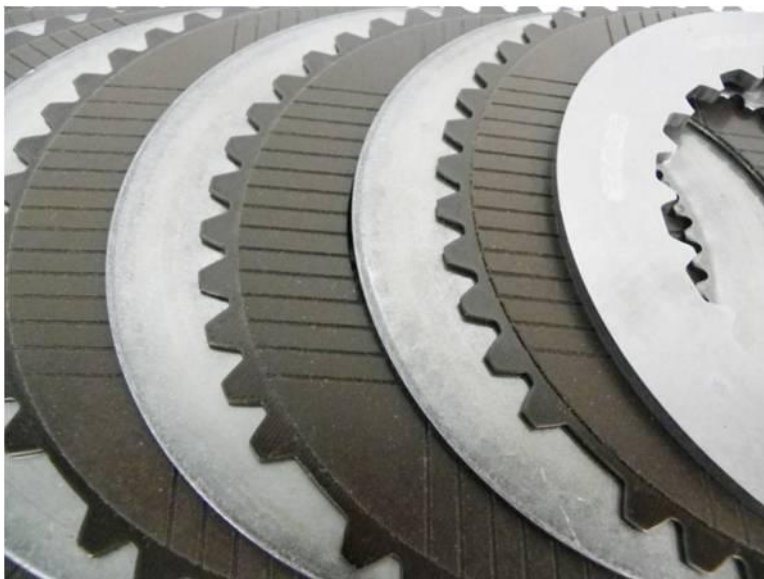
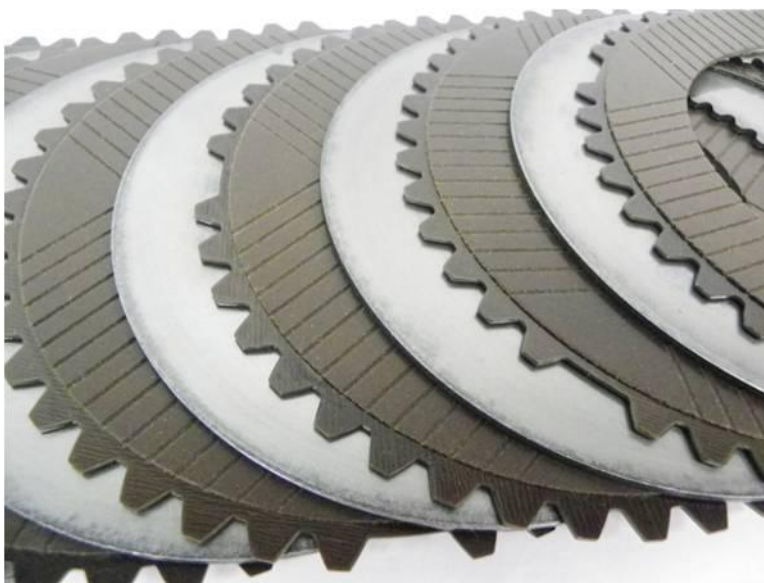
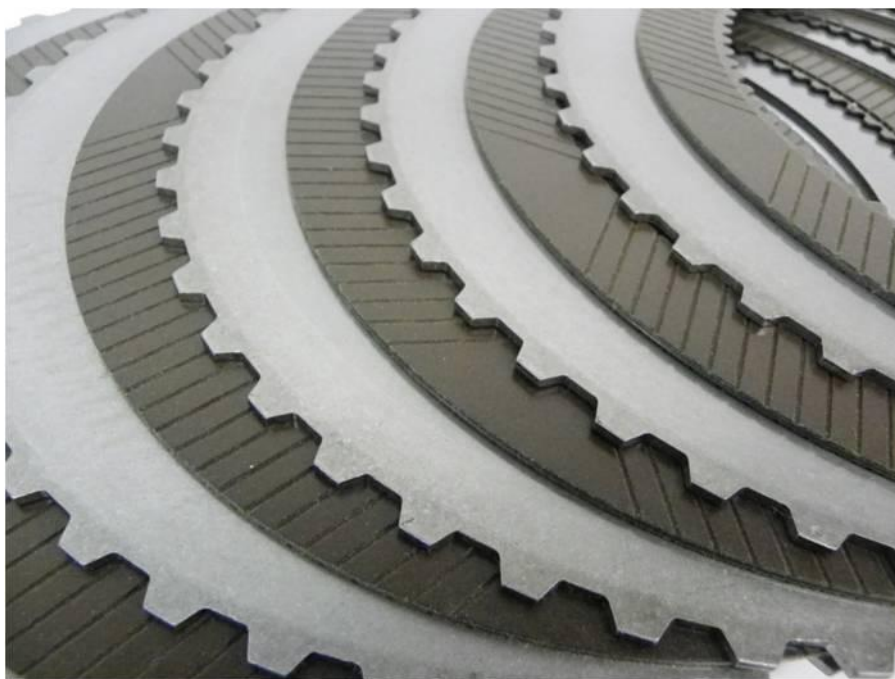
Figure 7 through Figure 10 show close up photos of the C1 and C2 clutch composition surfaces for both the TEST and CONTROL. As shown, both assemblies were found to be in excellent condition, without evidence of excessive heat, wear, or distress of the friction or steel reaction plate surfaces.

Figure 7. CONTROL Transmission C1 Clutch Assembly (Close-up)

Figure 8. TEST Transmission C1 Clutch Assembly (Close-up)

Figure 9. CONTROL Transmission C2 Clutch Assembly (Close-up)

Figure 10. TEST Transmission C2 Clutch Assembly (Close-up)

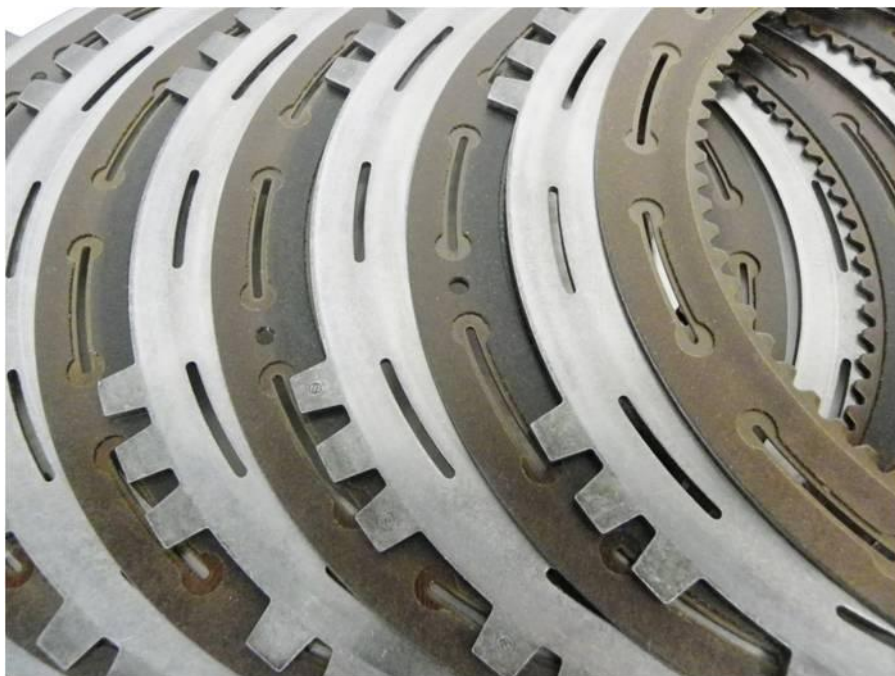
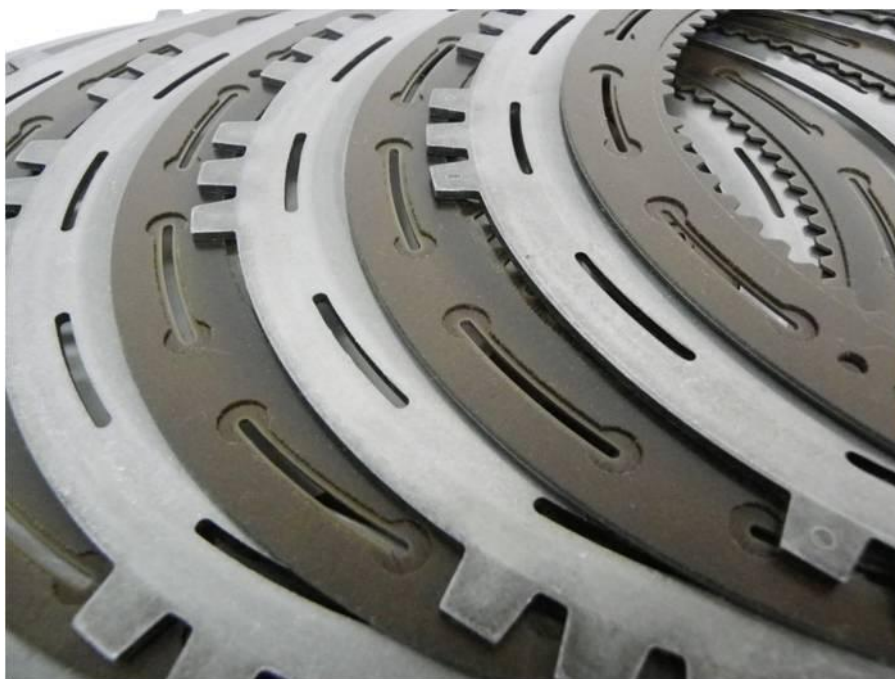
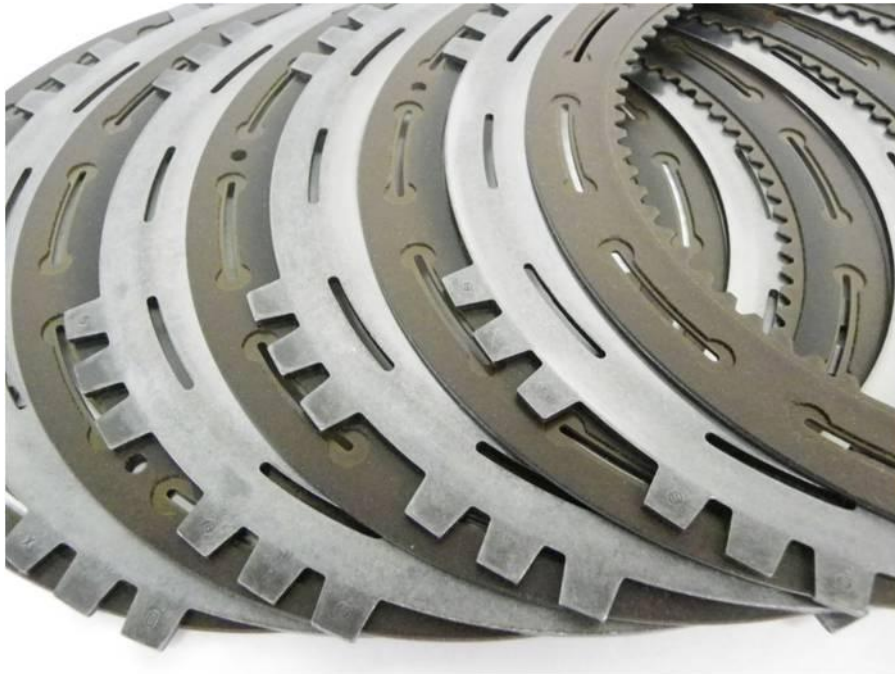
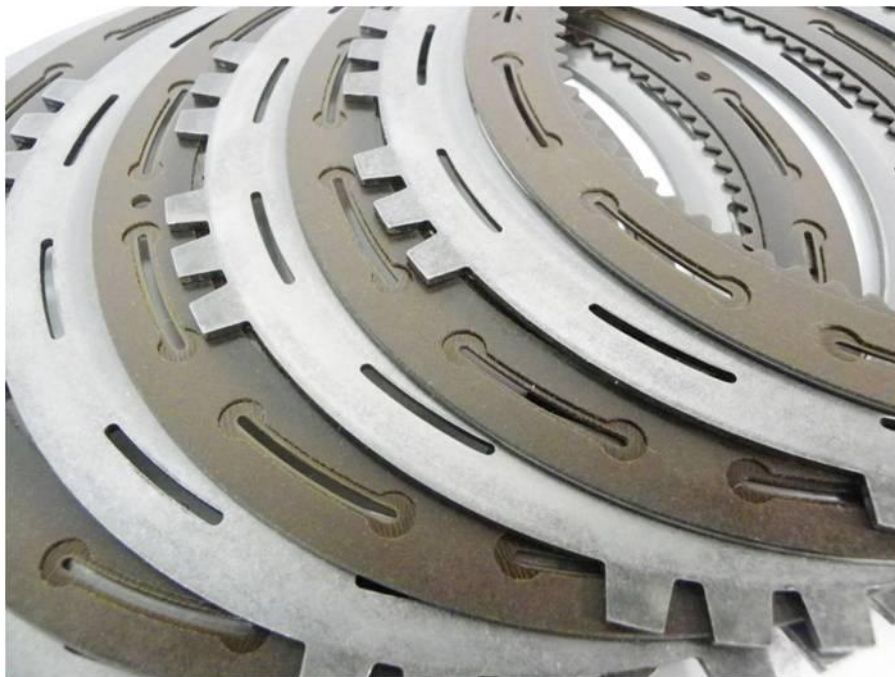
Figure 15 through Figure 18 (next 2 pages) show close up photos of the C3 and C4 clutch disks composition and reaction plates for both transmissions. This close-up shot better shows the discoloration present on the composition disks, but also conveys its overall minor nature.

Figure 15. CONTROL Transmission C3 Clutch Assembly (Close-up)

Figure 16. TEST Transmission C3 Clutch Assembly (Close-up)

Figure 17. CONTROL Transmission C4 Clutch Assembly (Close-up)

Figure 18. TEST Transmission C4 Clutch Assembly (Close-up)

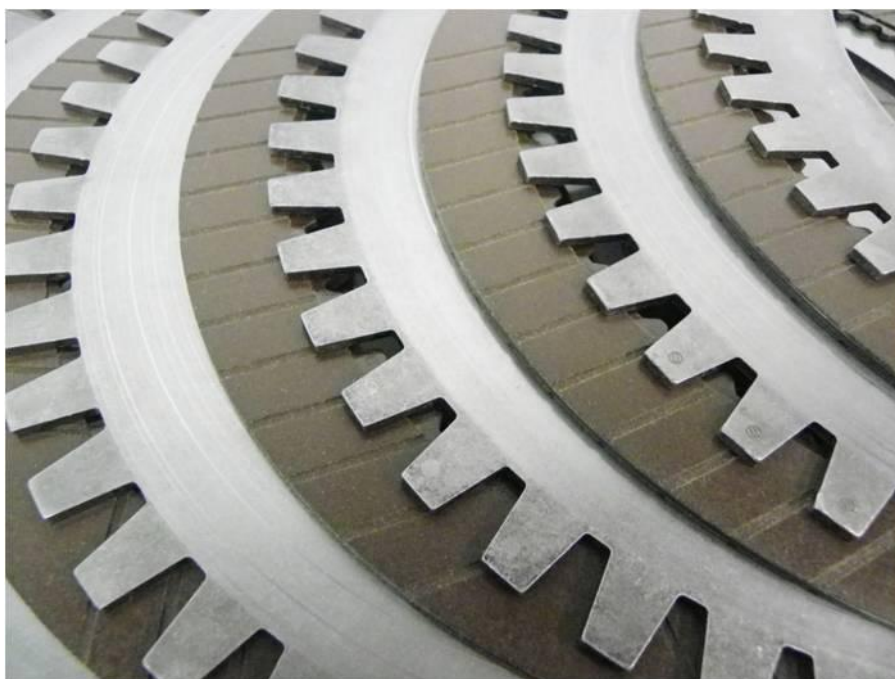
Figure 19 and Figure 20 show the C5 clutch assemblies. Like the C1 and C2 clutches, overall condition was found to be good, and both the TEST and CONTROL yielded similar component conditions. Figure 21 and Figure 22 (next page) show the close-up shots of the composition and reaction plates for the C5 assembly.

Figure 19. CONTROL Transmission C5 Clutch Assembly

Figure 20. TEST Transmission C5 Clutch Assembly

Figure 21. CONTROL Transmission C5 Clutch Assembly (Close-up)

Figure 22. TEST Transmission C5 Clutch Assembly (Close-up)

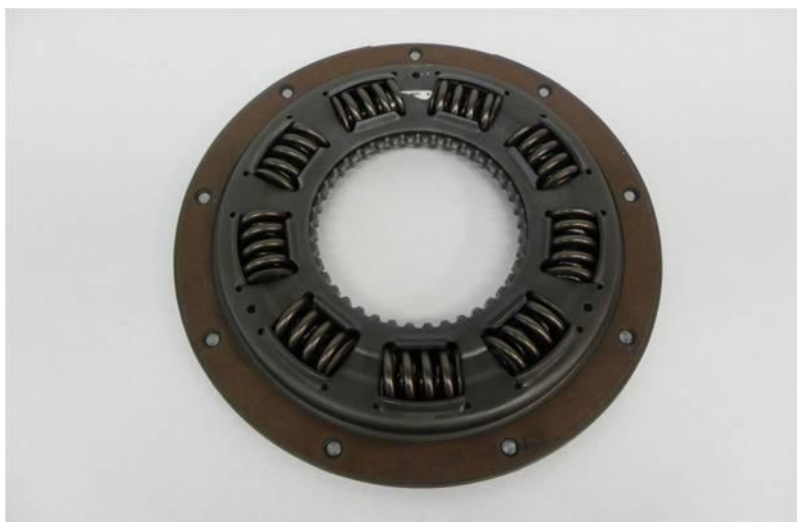
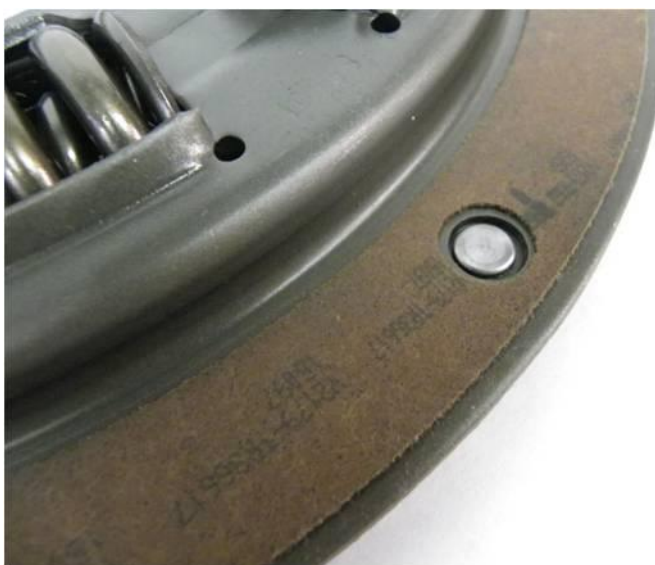
For the lockup clutch, neither of the assemblies showed excessive wear or signs of glazing consistent with results seen in all other clutch assemblies. Figure 23 and Figure 24 show the CONTROL transmission lockup clutch. As previously mentioned, factory markings can still be seen on the composition surface indicating little wear occurred to the composition material.

Figure 23. CONTROL Torque Converter Lockup Clutch

Figure 24. CONTROL Torque Converter Lockup Clutch (Close-up)

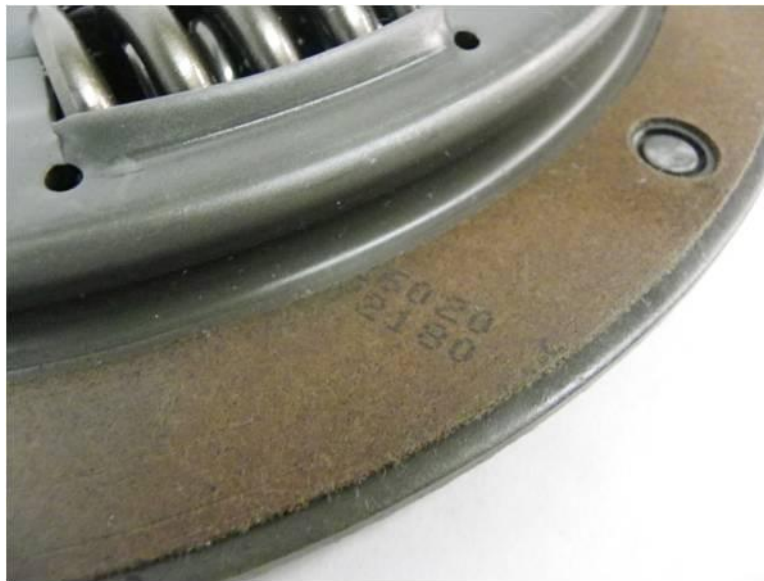
Figure 25 and Figure 26 show the lockup clutch photos for the TEST transmission. Like the CONTROL unit, factory markings can still be seen on its composition surface as well.

Figure 25. TEST Torque Converter Lockup Clutch

Figure 26. TEST Torque Converter Lockup Clutch (Close-up)

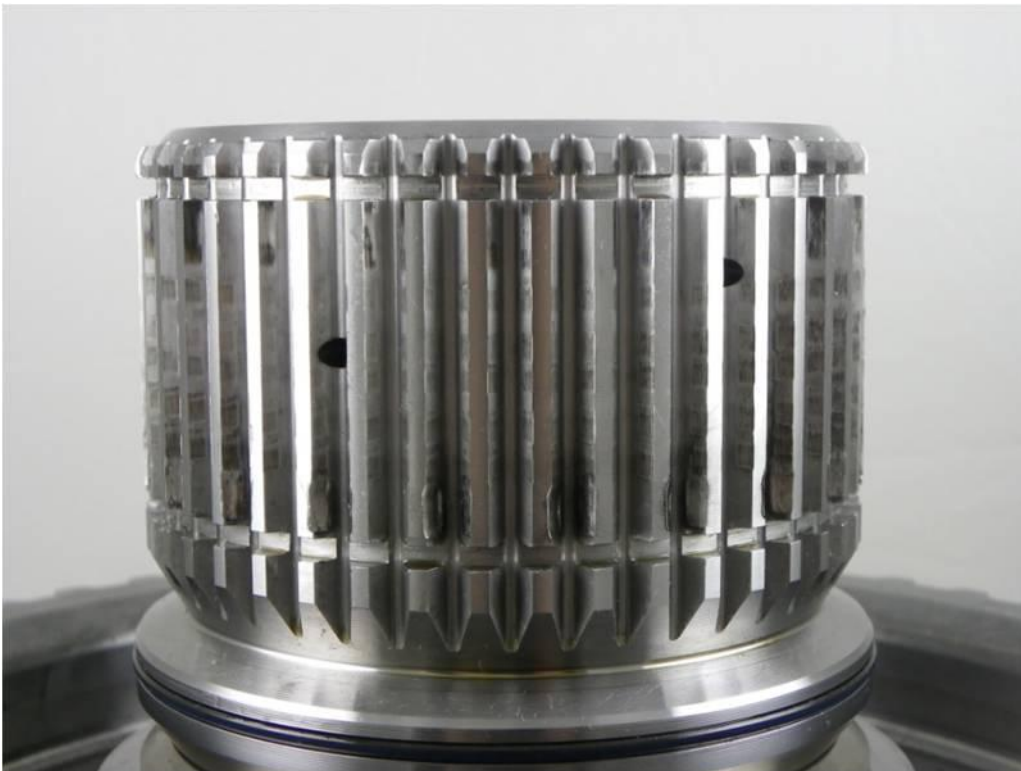
As previously mentioned, the main area that did stand out during inspection were signs that the TEST transmission had undergone some sort of previous service or rebuild. The primary support of this was wear noted on the splined shaft of the rotary clutch drum assembly. During its inspection, heavy contact wear was noted on every other spline on the shaft in the area where the balance piston rides and engages. This can be seen below in Figure 29, and again in a close up photo in Figure 30.

Figure 29. TEST Transmission Balance Shaft Spine Wear

Figure 30. TEST Transmission Balance Shaft Spline Wear (Close-up)

As shown, the wear was found present on every other spline tooth on the shaft, and is consistent with the skip tooth engagement of the balance piston that rides on the shaft and engages the splines (Figure 31).

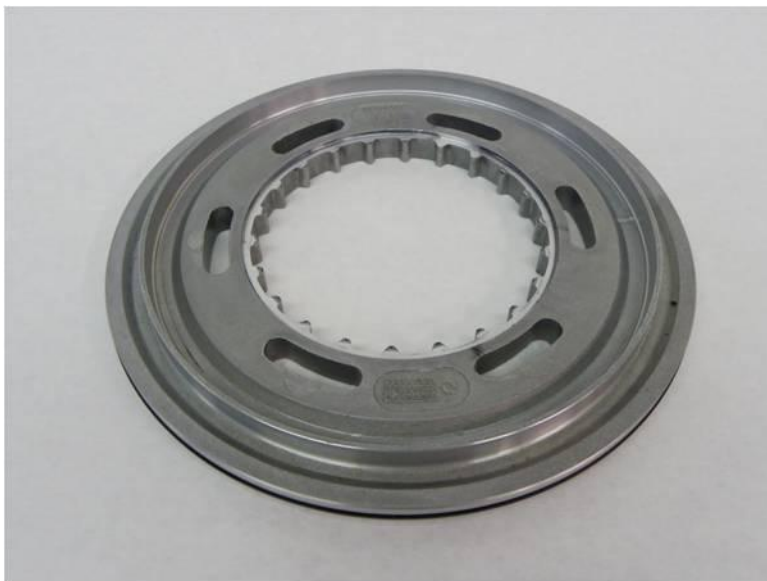
Despite the wear seen on the shaft splines, the engagement teeth of the TEST transmission balance piston (shown in Figure 32 and Figure 33) did not show corresponding damage when inspected. This is inconsistent with what would be expected based on the shaft spline wear.

Figure 32. TEST Transmission Balance Piston

Figure 33. TEST Transmission Balance Piston (Close-up)

This unusual wear discrepancy serves as the single biggest indicator that the TEST transmission had sometime in its history received major service/rebuild prior to the RAM-D testing. The balance piston, which is comprised of a relatively soft aluminum alloy, would have been expected to show significant corresponding wear to that seen on the harder splines if in fact the spline wear was a result of current testing. As the TEST transmission balance piston teeth appear to be virtually unworn, this indicates that the orientation of the balance piston upon installation was such that the piston teeth were NOT in contact with worn shaft splines, and had instead sometime previously been re-indexed during service to the unworn splines. As stated by the Allison transmission technicians, this is common practice in transmission overhaul, as the skip tooth engagement allows reinstallation of a new piston and reuse of the partially worn shaft by changing the engagement orientation to the unworn teeth. This type of action reduces the cost of an overhaul, as the rest of the balance shaft would still remain in usable condition apart from the localized wear that cannot be avoided. Since the balance piston removed from the RAM-D TEST transmission showed virtually no wear, it can only be surmised that the wear seen on the balance shaft splines was pre-existing. There was no evidence that the wear occurred as a result of SCPL use, and nothing was found to suggest that this issue could have biased the results of testing.
